## Timeout Error When Charging The CUE-D300

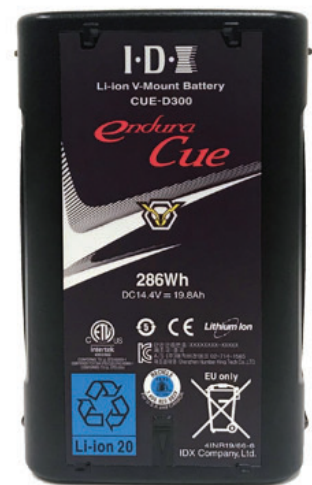
Due to CUE-D300 being an extra high capacity 286Wh battery, some chargers have displayed 'Blinking Amber' error status when the battery charge reaches about 90% full.  
(Only happens if the CUE-D300 is at minimum to 0% charge when inserted on the charger)

- \* Limit simultaneous charging to 3 batteries at a time.
- \* When charging 4 batteries simultaneously, reseal the batteries after 2 hrs of charging or when 'Blinking Amber' error is displayed.

- \* Reseat the batteries when 'Blinking Amber' error is displayed.

- \* New charger firmware to address the issue is available through our Service Dept. (*service fee applies*)
