## Firmware Update (Compatibility w/ IPL Series)

The new PowerLink technology in both IPL-98 & IPL-150 allows for up to four batteries to be stacked charged when used with the VL-2000S charger. To take advantage of this new feature, current owners of the VL-2000S charger will have to install the newest firmware.

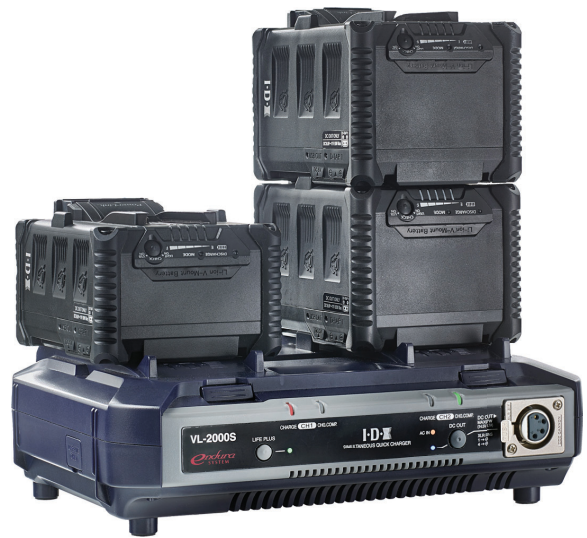
1. Download firmware (.zip) from the link provided.
2. Unzip and copy the 2 files to the root folder of the blank USB flash drive.
3. Remove all batteries and the AC cable from the charger and wait for all LED to turn off.
4. Insert the USB flash drive with the firmware into the USB port on the side of the charger.
5. Plug in the AC cable.
6. The charger will boot up with all LED lit solid for 3 sec, and then will blink during the installation.  
\*Do not remove the USB flash drive during installation (LED blinking)\*
7. After a few seconds, LED will turn off and the installation is complete.
8. VL-2000S can now stack charge!
